Case Study

Using HD-FOS for Defect Detection in Wind Turbine Blades During Fabrication and Testing

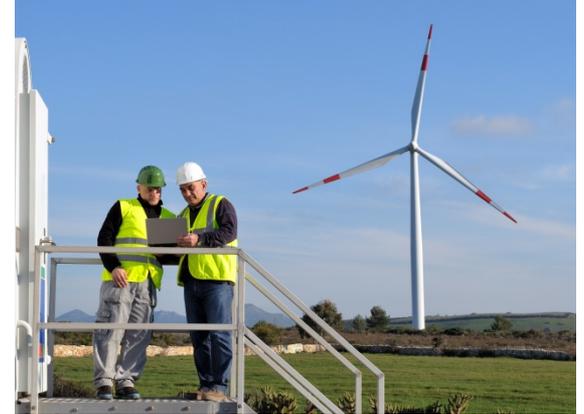
Design a “Smart” wind turbine blade that can predict when and where defects within the construction could cause potentially catastrophic failure

The sensing solution must be robust, embeddable, cost effective, provide thousands of strain sensing locations with a nearly zero weight budget

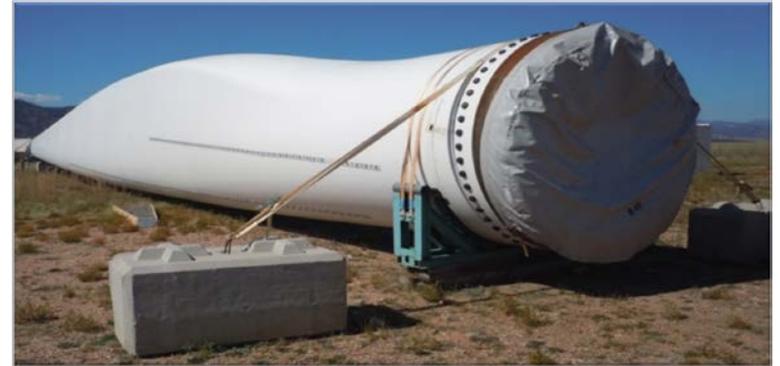
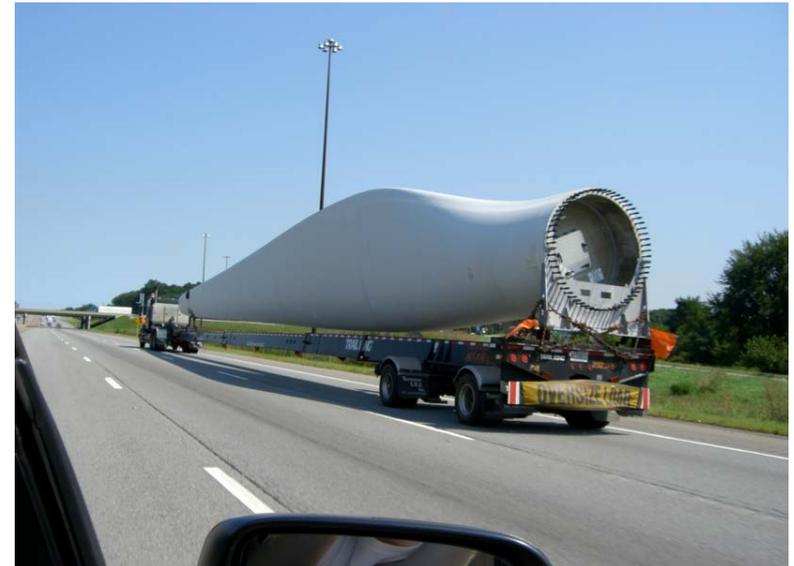
New methods are needed for strain measurement to characterize residual strains during layup, to detect incongruities in the composite structure and to measure strain across the joints and seams using new advanced adhesives

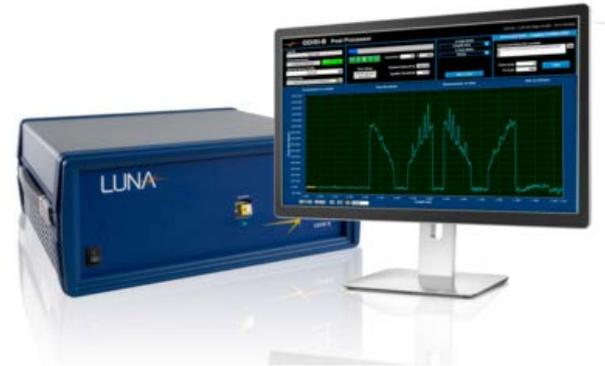
The Interrogator

An Optical Backscatter Reflectometer (OBR) was used in this test. Luna offers several models of OBR with strain and sensing capability. At right is Luna's ODiSI, an OBR optimized for strain and temperature sensing

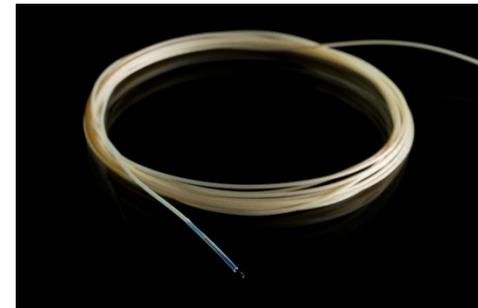
The Sensor

The turbine blade was instrumented with HD-FOS sensors. Sensors are lightweight, minimally invasive and can be embedded within composites. The fiber is EMI immune and introduces has no electrical signal (no source of ignition)

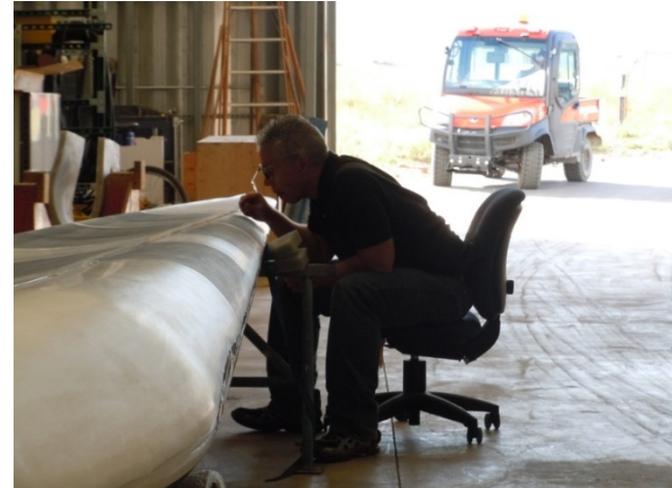
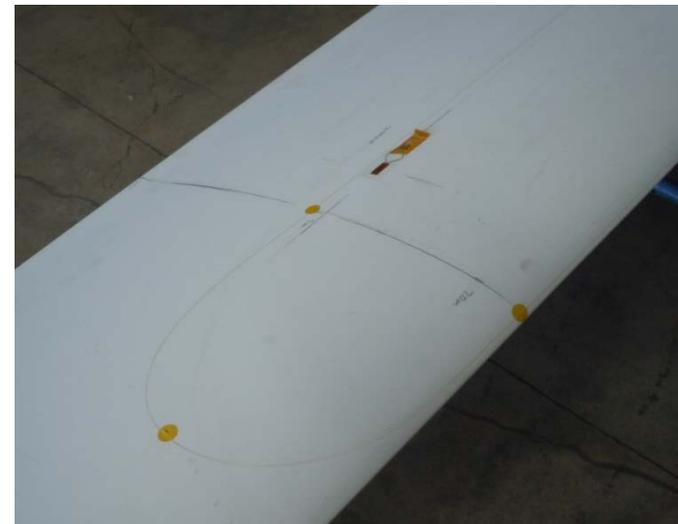
Three optical fibers were bonded to the turbine blade surface using M-bond AE-10 strain gage epoxy. The bonding of fiber is similar to bonding strain gages and the same epoxies are used

An HD-FOS sensor bonded to the surface of the turbine blade

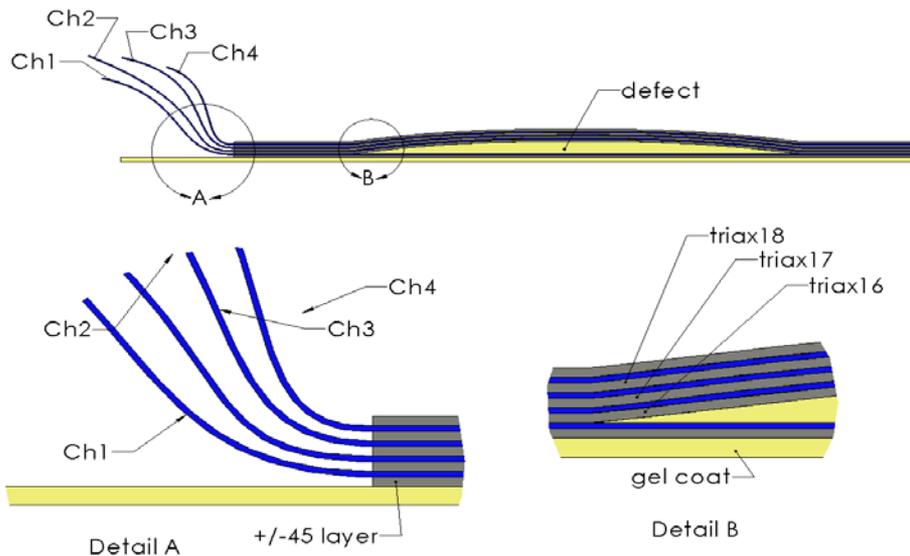
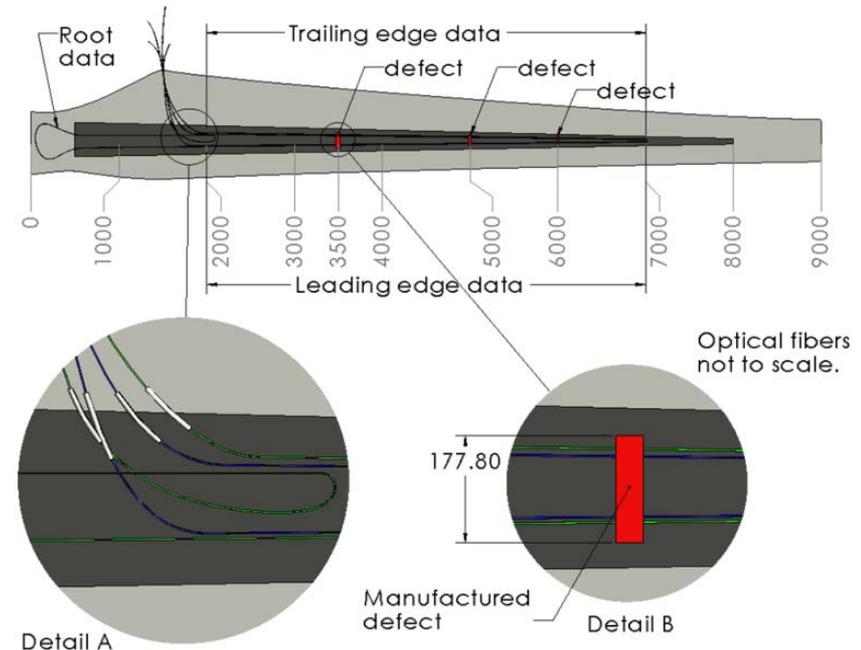
“Smart Blade” Construction: Embedding Sensors to Capture Defects in the Manufacturing Process

- Fiber sensors were embedded in four layers of composite blade construction
- Intentional defects were introduced at three locations to simulate waviness in the composite lay up.
- The wave height of all defects was 3mm. The defect lengths were 45 mm, 30 mm and 15 mm for aspect ratios of 15, 10 and 5 respectively

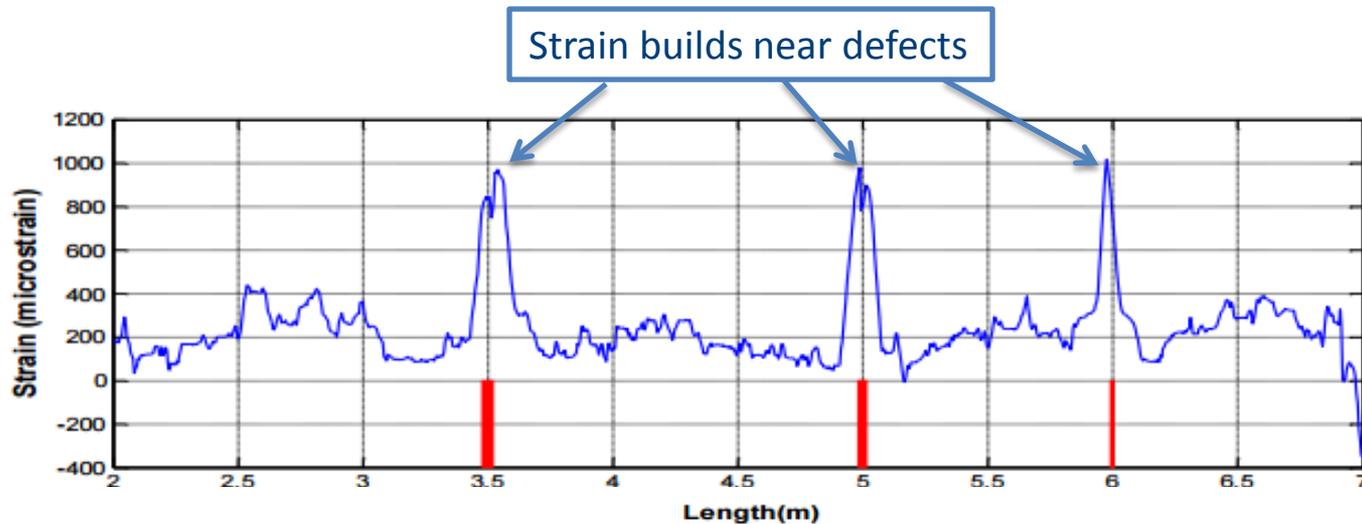
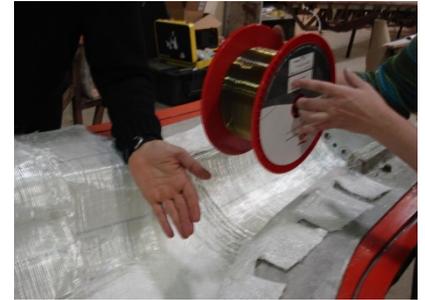
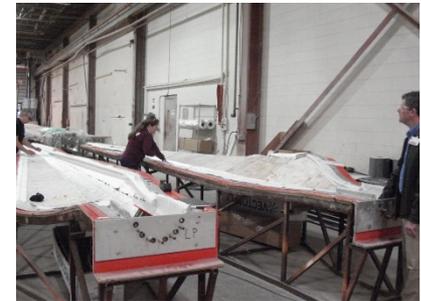
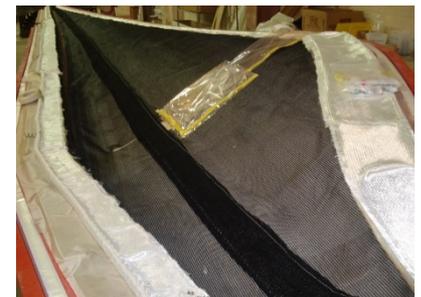
A Low Profile and Minimally Intrusive Sensor Suitable for Embedding During Composite Fabrication

- HD-FOS strain data from embedded sensors clearly show high gradients corresponding to location of defects. The width of the strain peaks correlate with the width of the induced defect
- High resolution HD-FOS finds defects other technologies simply miss

- **High Definition Sensing Provides a Complete Picture of Strain Gradients** – The high definition sensing showed the full distribution of strain as well as the shape of the strain profile in the vicinity of the defects. The profile of the strain gradient correlated with the type of defect induced in manufacturing

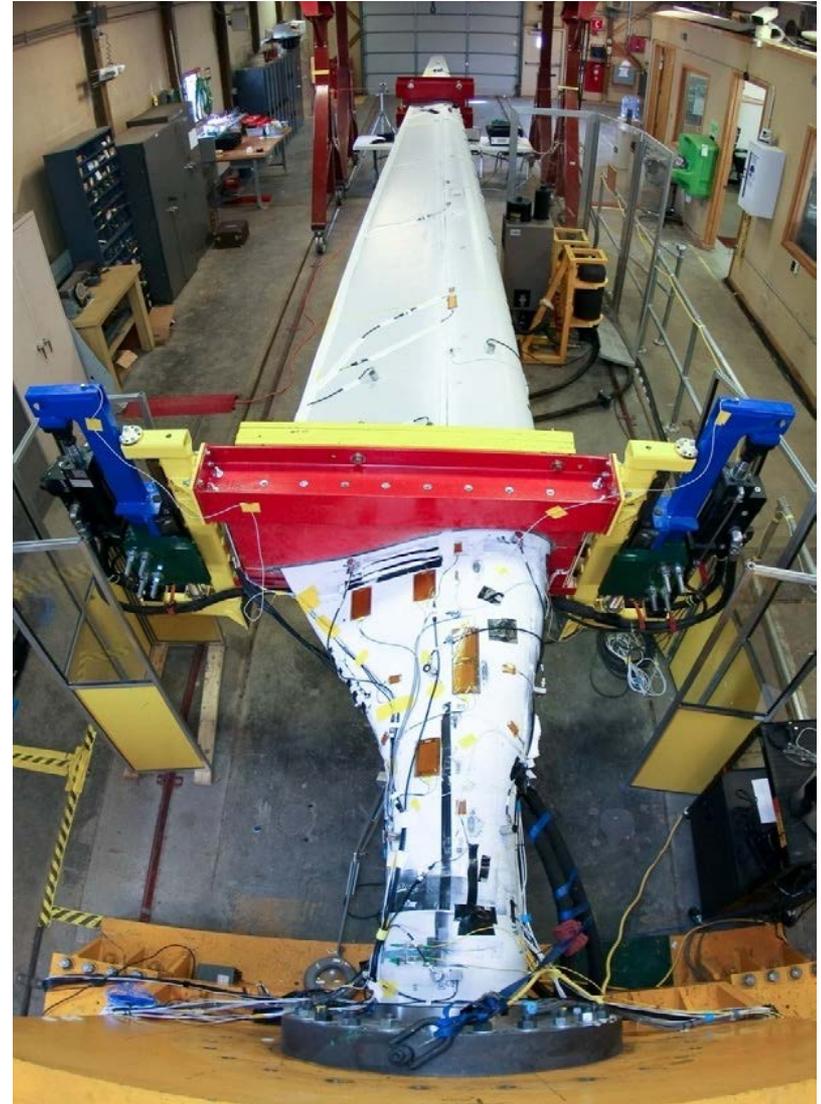
Cyclical Load Testing to Failure

- The turbine blade was mounted in a cantilevered load test stand
- A Universal resonant excitation (UREX) system used to apply an alternating bending moment at natural frequencies
- A cyclical load applied at ± 500 lbs
- At periodic cycle counts the turbine blade was statically loaded and data was taken from both the surface mounted HD-FOS sensors and point sensing strain gages

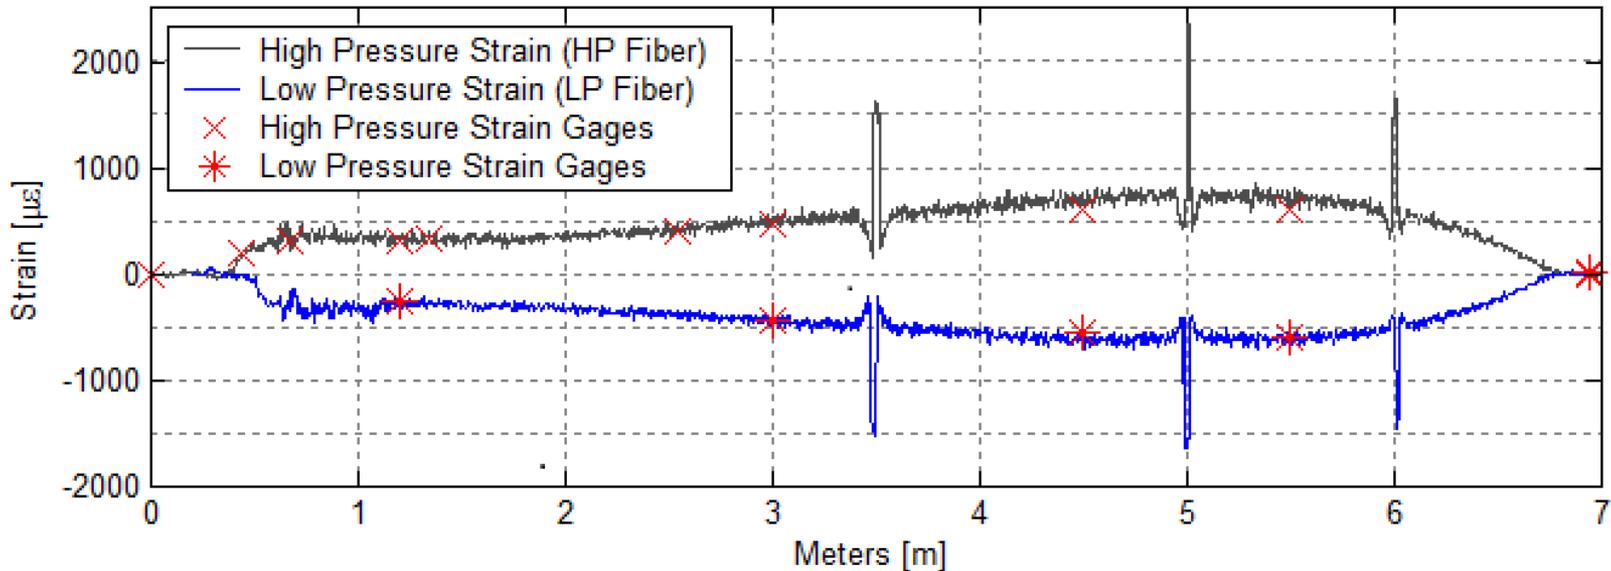
Strain Measured with HD-FOS on Surface of Blade Under Load

- The data showed excellent correlation between the HD-FOS sensor and the co-located strain gages
- The location of the strain peaks correlated with the location of intentionally induced defects
- The highest strain peak, at location 5 meters along the blade length, is where the turbine blade would eventually fail during fatigue testing

- **Excellent Correlation with Traditional Strain Gages** – The strain data taken with HD-FOS showed excellent correlation to the individual point sensing strain gages

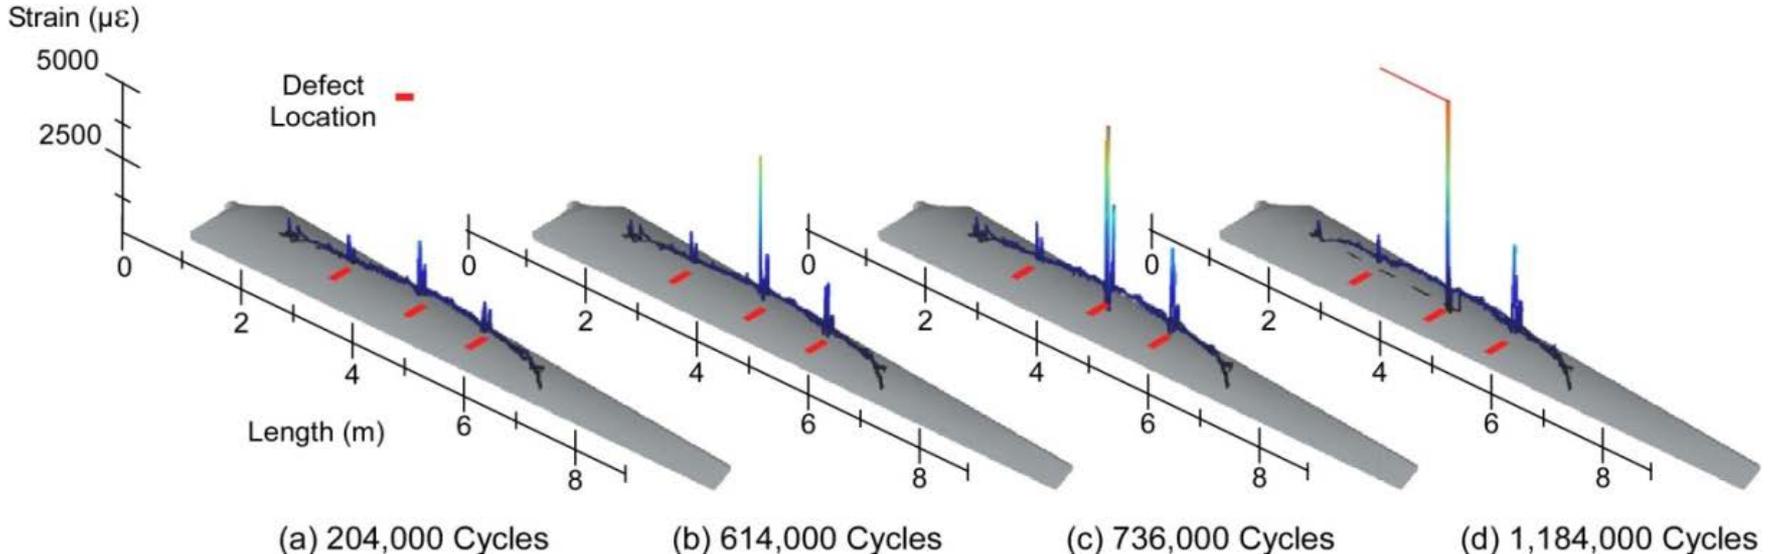
Strain Measurements Taken as Cycle Count Increases

- At 614,000 cycles and prior to any visible damage, an X% increase in strain could be observed at the 5 meter induced defect point
- A visible crack eventually formed and failure occurred at this location at 1,968,000 cycles
- HD-FOS was also able to identify and track the evolution of other defects that did not ultimately result in blade failure

- **Identify Crack Initiation and Chart the Crack Propagation Leading to Failure** - During fatigue testing the HD-FOS sensors indicated early in the test the eventual location of failure well before failure occurred. The sensitivity of HD-FOS was able to identify the location of the eventual failure point early in its development and track the growth of the defect leading up to failure
